6 National Dam Inspection Program.  
Liberty Dam, Upper Chesapeake Bay  
Basin, State of Maryland, Baltimore  
and Carroll Counties (NDS-MD-3).  
Phase I Inspection Report.

LIBERTY DAM

## PHASE I INSPECTION REPORT

Name of Dam: LIBERTY DAM  
State & State Number: MARYLAND - MD-3  
County: BALTIMORE & CARROLL  
Stream: NORTH BRANCH PATAPSCO RIVER  
Date of Inspection: August 1, 1978

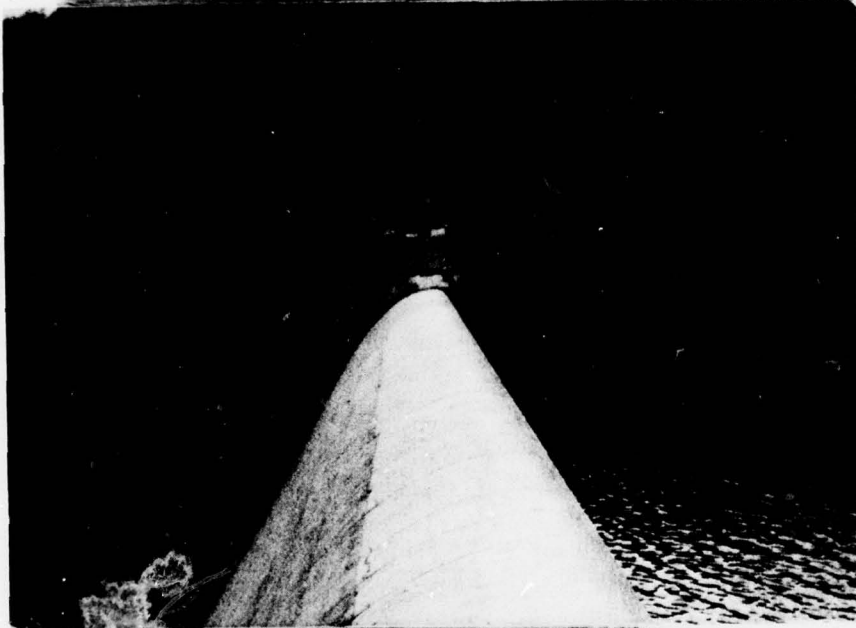
Spillway  
Looking West

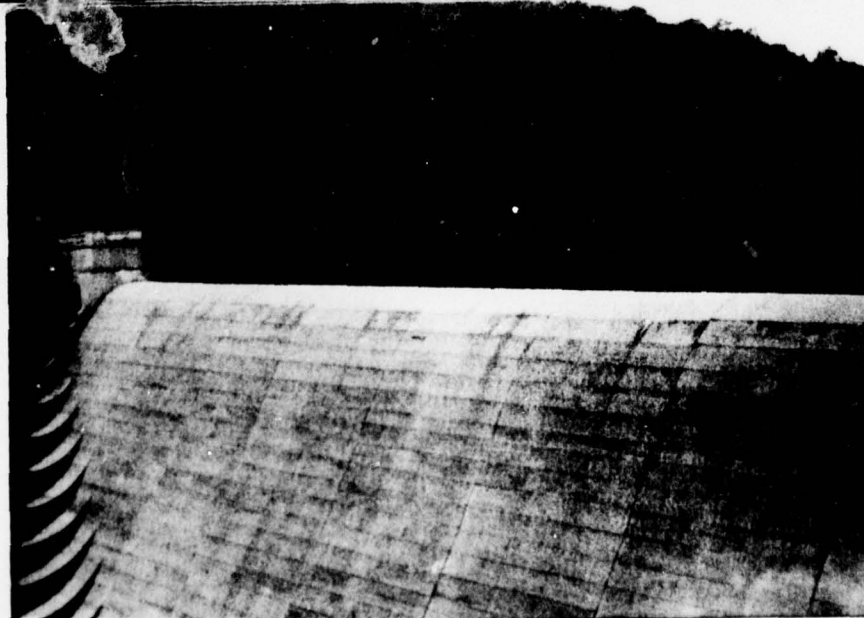
Spillway Surface

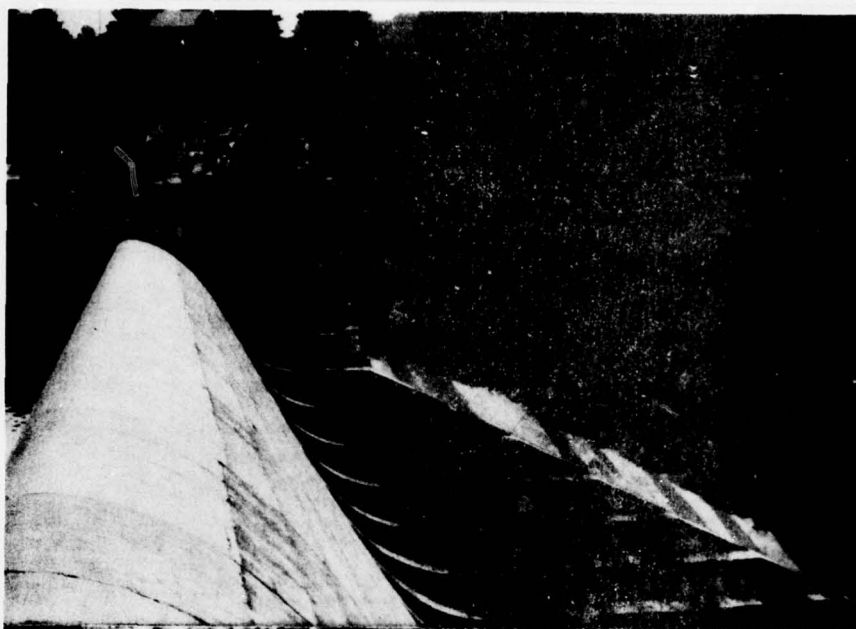
Spillway  
Looking East

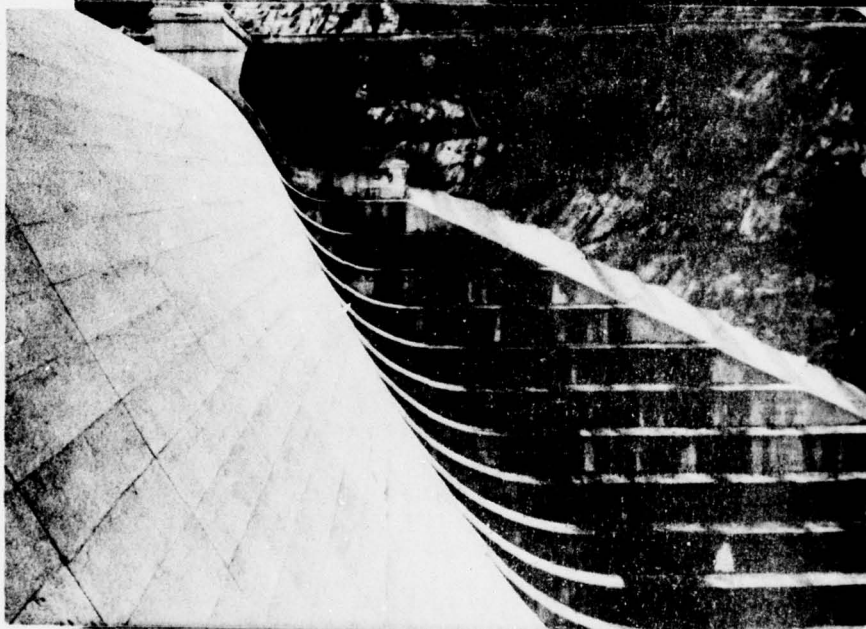
Spillway Surface

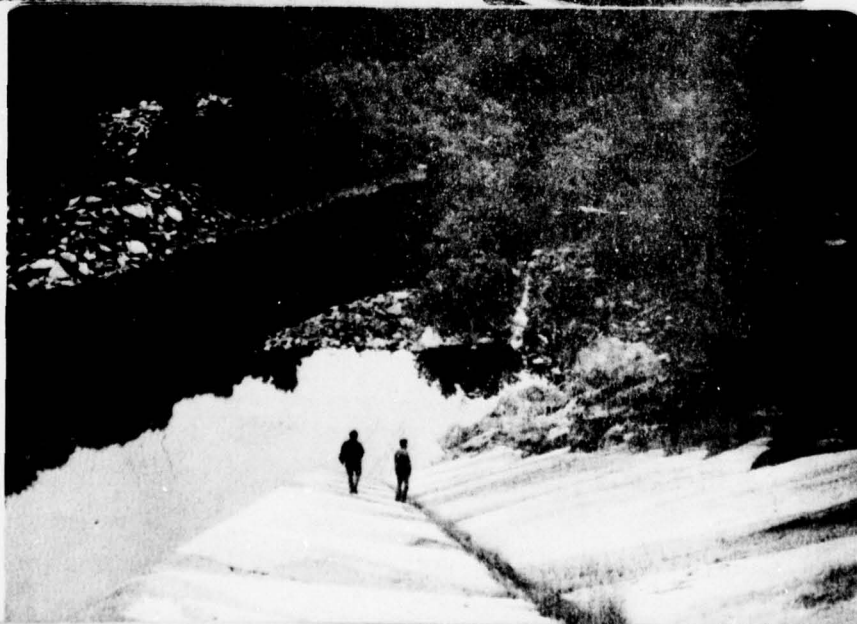
West Spillway Wall  
& Downstream Channel

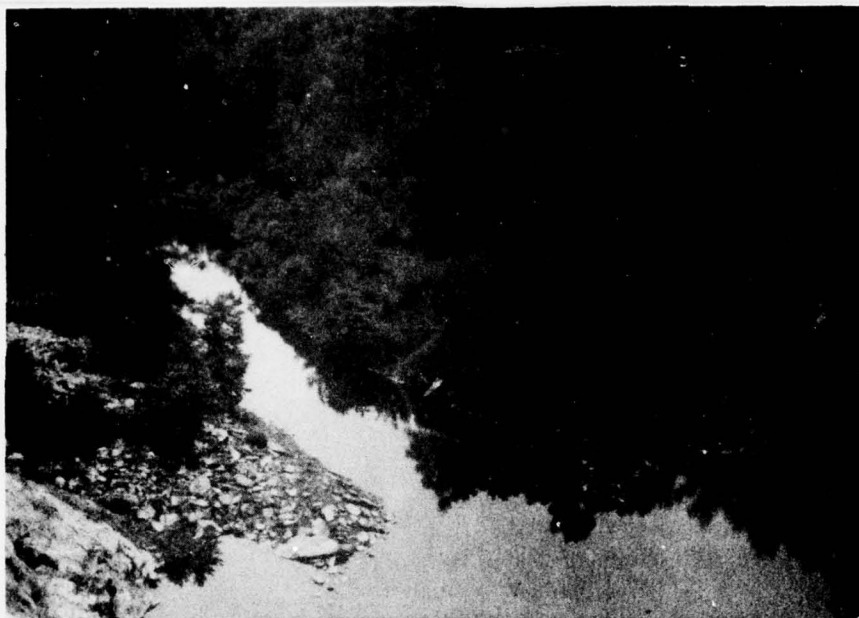
Downstream  
Channel

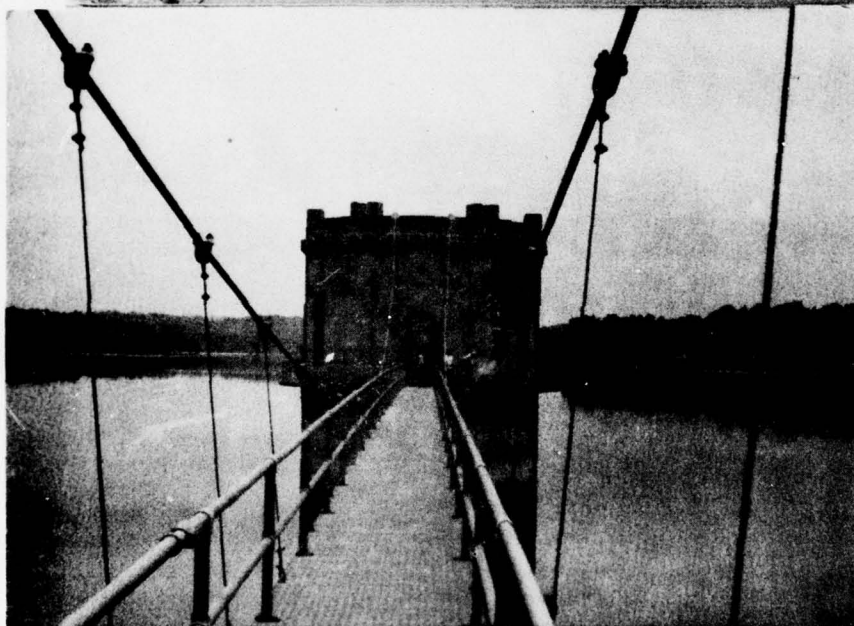
The only operating facilities at the dam are the low flow pipes which have not been opened since 1966. All other operating facilities are located in the intake structure, 1.5 miles upstream. This structure is well maintained and all gates are in excellent condition.

Intake Tower

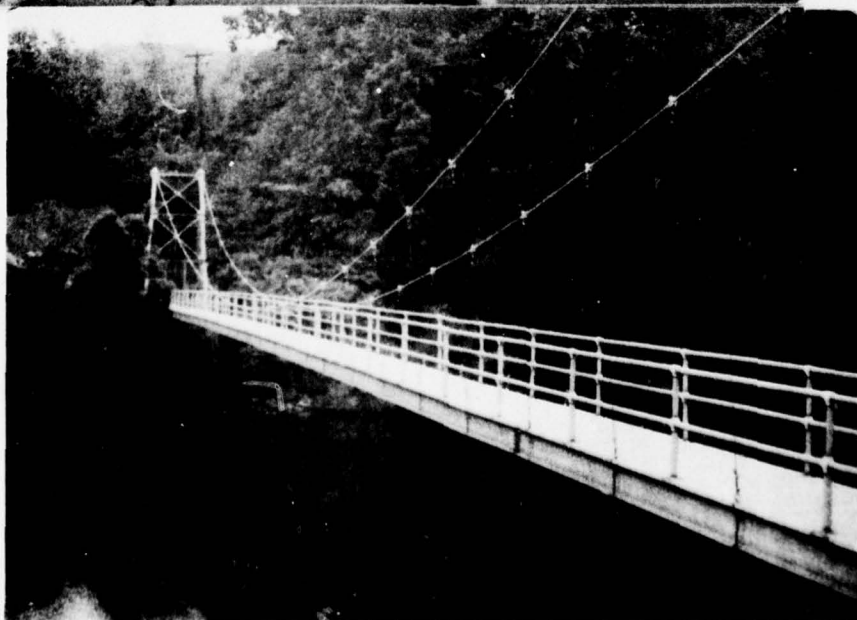
Bridge To  
Intake Tower
